REPORT NO: MT-11/362-A

## TESTING OF A NBS CLASS B TEMPORARY FENCE SYSTEM

CLIENT: NEW BRIDGE SERVICES  
5 FERNWREN DRIVE  
BERWICK VIC 3806

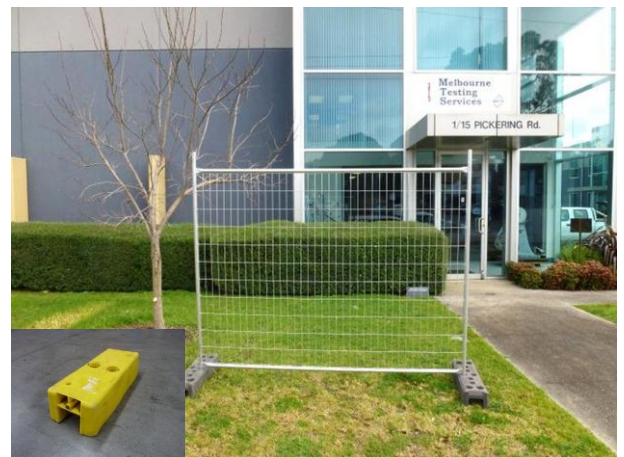
**FIG.1**  
**FENCE TEST PANEL SET-UP**  
**(INSET CONCRETE FOOT BLOCK)**

The fence panels were assembled in accordance with the clients written instructions. Prior to testing the tubular back braces were modified to provide a positive interlocking connection to the underside of the block footings. This was done to prevent slip and improve the fence’s stability and wind load performance. With this in mind, the test results as reported herein are strictly specific to the modified brace version of the fence system.

Temporary fence panels were prepared for testing in both single panel and continuous panel configurations. Continuous panel testing was conducted on a three panel assembly with the middle panel being the focus of the testing. The temporary fencing was assembled using the supplied clamping fixtures and in accordance with the manufactures assembly guidelines.

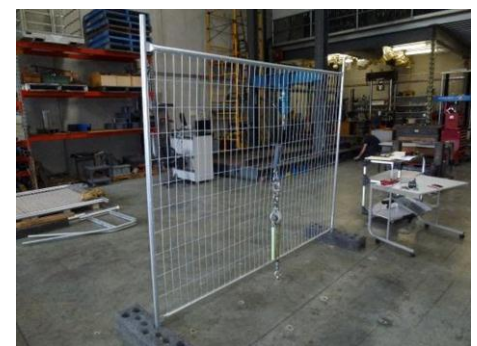
To test that the infill mesh had sufficient stiffness to resist an attempt to climb the fence, a downward load of 100kg was applied at one of the rectangular shaped openings (see Fig.4). This load was maintained for 60 seconds at which point the downward deflection of the infill material was recorded.

**FIG.4  
INFILL DOWNWARD TEST**

Infill downward load test resulted in a deflection of **6mm**, less than the specified permissible maximum of 35mm.
